Pentium® II Processor Specification Update

Release Date: February 2000

Order Number: 243337-034

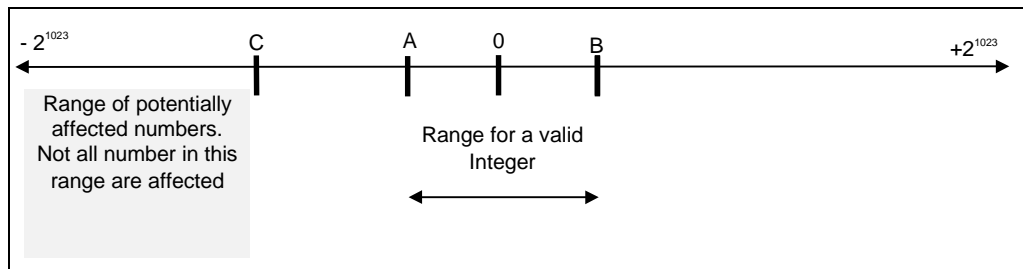
Implication: Erroneous operation results when the operand is so large that it will not fit into the target data size. The operands affected by this erratum are significantly outside (by a factor of 3X) the range that can be, correctly, converted to an integer value. The figure below and corresponding table identifies the normal range of integer numbers (between A and B) and the starting point of the operands affected by this erratum. Discrete failing operands will be present in the range between point C and the maximum negative number that can be represented by the processor (-2^{1023} in double precision format). Note 2 below gives a qualitative description of the nature of the discrete failing values. Software that does not rely on the Invalid Operation exception flag being set and signaled by either an exception OR by software polling is not impacted by this erratum.

16-bit Operation	A	B	C
	-32,768.0	+32,767.0	< -98304.0
32-bit Operation	A	B	C
	-2,147,483,648.0	+2,147,483,647.0	< -6,442,450,944.0
